Villa Kennedy Housing Complex Reconnaissance Inspection

VILLA KENNEDY HOUSING COMPLEX STORMWATER AND WASTEWATER COLLECTION SYSTEMS

Reconnaissance Inspection: Municipality of San Juan Municipal Separate Storm

Inspection Date: July 16, 2014

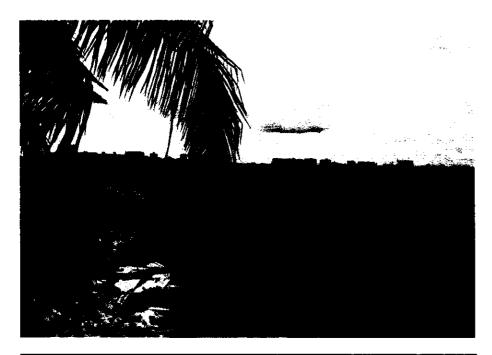
- 19. During the inspection we found the estuarine wetland area of the Los Corozos Lagoon located to the northwest part of the Villa Kennedy Housing Complex being filled by construction and demolition debris and other rubbish. The estuarine wetland vegetation was also impacted and removed in some areas. The Los Corozos Lagoon was also found with significant amounts of trash and other solids accumulated on its shore.

Photo #28 and 29 – View of the northwest part of the Villa Kennedy Housing Complex bordering the Los Corozos Lagoon. The lagoon was found with significant amounts of trash accumulated on its shore. Additionally the area estuarine wetlands were found filled by construction debris and other rubbish.

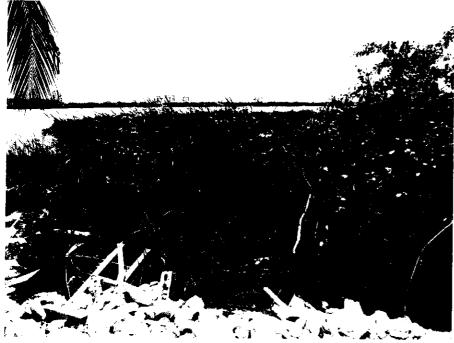
Photo #30 and 31 - View of the northwest part of the Villa Kennedy Housing Complex bordering the Los Corozos Lagoon. The area estuarine wetlands were found filled by construction debris and other rubbish. The estuarine wetland vegetation was also impacted and removed in some areas.
